BUILDER INSIGHT

Bulletin No 5 | Vienna House

Testing of Envelope Details

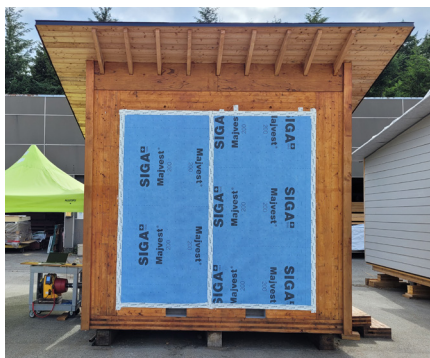
Figure 3. RAIN chamber with the mock-up wall installed (source: FPInnovations).

FPInnovations used the Rain and Air Infiltration (RAIN) Chamber located in the rear yard of their Vancouver laboratory (Figure 3).

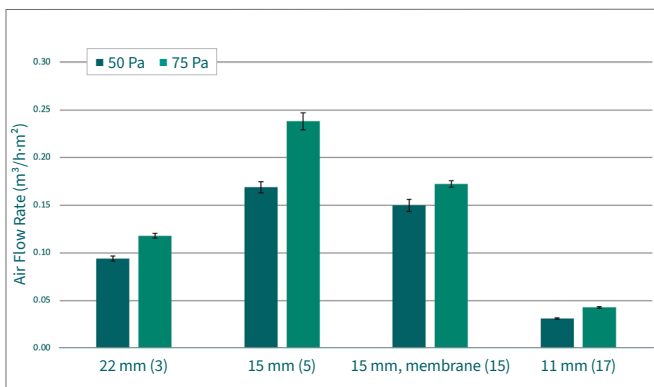
Figure 11. Effect of thickness of OSB sheathing and a combination of exterior water-resistive barrier, on air flow with taped joints (source: FPInnovations).

OSB sheathing panels in three thicknesses were assessed in this study. The panels were taped along the centre joint and around the perimeter with Siga Rissan tape. Note there was significant uncertainty in the measurement of the 11 mm thick OSB as testing was conducted following the water penetration test, which appeared to have affected the airtightness of the chamber. The result shown in Figure 11 is much lower than would be expected for this material, so caution is needed to understand its real performance.

Testing under consistent conditions prior to the water penetration test, using the 22 mm thick OSB internal sheathing demonstrated a much lower air flow rate compared to the 15 mm OSB (Figure 11). Air flow was 44% lower at 50 Pa pressure difference than the assembly using the 15 mm thick OSB sheathing, and 50% lower at 75 Pa pressure difference. The taped 22 mm OSB alone, or the taped 15 mm OSB together with the exterior WRB membrane, showed an air flow below $0.18 \text{ m}^3/\text{h}\cdot\text{m}^2$ measured at 75 Pa, meeting the NBCC requirement for Class 1 Air Barrier Assembly (NRC 2020a).

- The taped 22 mm thick OSB sheathing was found to provide a much lower air flow, compared to the taped 15 mm OSB. The taped 22 mm OSB alone, or the taped 15 mm OSB together with the exterior WRB membrane showed an air flow below $0.18 \text{ m}^3/\text{h}\cdot\text{m}^2$ measured at 75 Pa, meeting the NBCC requirement for Class 1 Air Barrier Assembly,
